DEPARTMENT OF TRANSPORTATION

Contract #: 04-0120F4Cty: SF/ALA Rte: 80 PM: 13.2/13.9File #: 99.28**WELDING INSPECTION REPORT****Resident Engineer:** Siegenthaler, Peter**Address:** 333 Burma Road**City:** Oakland, CA 94607**Report No:** WIR-018630**Date Inspected:** 14-Dec-2010**Project Name:** SAS Superstructure**OSM Arrival Time:** 700**Prime Contractor:** American Bridge/Fluor Enterprises, a JV**OSM Departure Time:** 1900**Contractor:** Zhenhua Port Machinery Company, Ltd (ZPMC) Chanxing Island**Location:** Shanghai, China

Bridge No: 34-0006**Component:** OBG Segment**Summary of Items Observed:**

WELDING INSPECTION REPORT

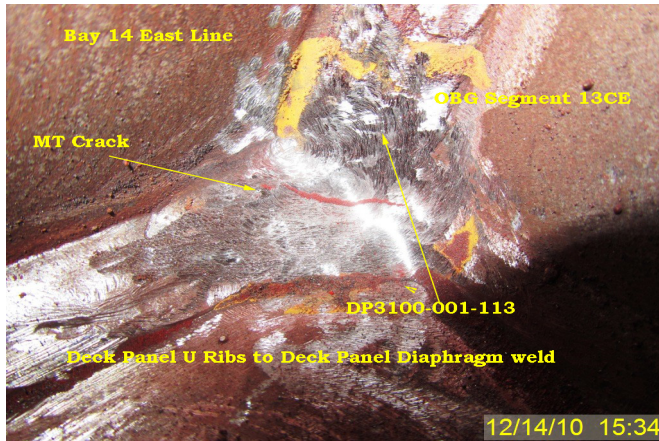
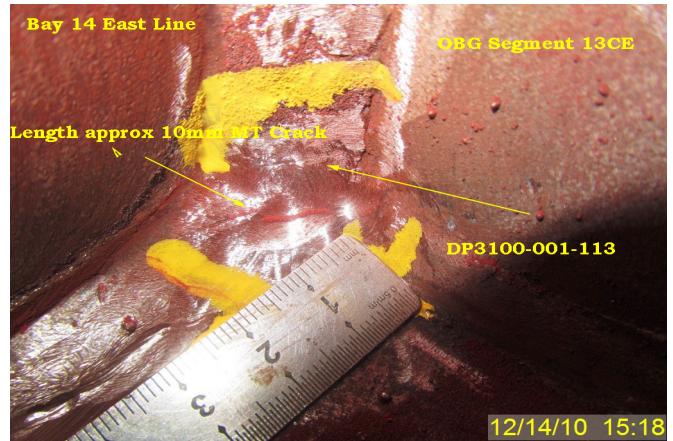
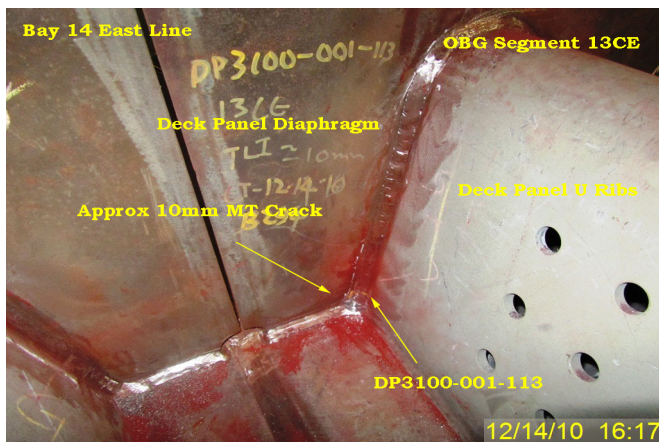
Description of Incident: During the Quality Assurance Magnetic Particle Testing (MT) review of welds located on Segment 13CE, this Quality Assurance Inspector (QA) discovered that one (1) MT crack measuring approximately 10mm in length. The weld is identified as: DP3100-001-113. This weld is a Complete Joint Penetration (CJP) weld joining the Deck Panel U-Rib to Deck Panel Diaphragm. The Deck Panel U-Rib and Deck Panel Diaphragm are identified as Non SPCM. This weld is designated as Non Seismic Performance Critical Member (Non SPCM). The

indication is clearly marked on the material near the weld. OBG segment 13CE is located East Side of Bay 14 area. The Indication is located within an area that has been previously tested by ZPMC Quality Control (QC) personnel. As per contract documents ZPMC is required to perform 100% Magnetic particle Testing (MT) of this weld. The ZPMC QC is identified as Mr. Wang Lu. See the attaché picture.
